# Spinning Brazilian Cotton

Case Study - 3

## About Company

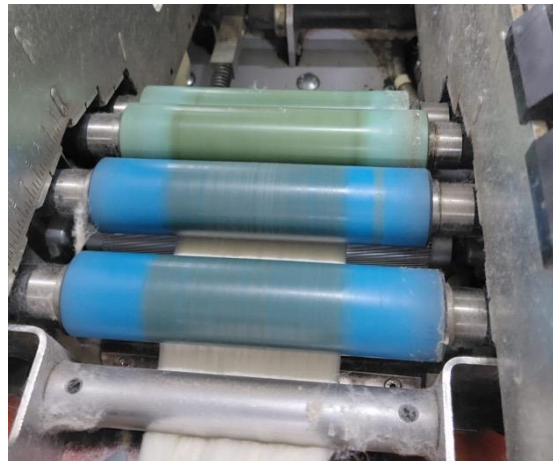
*Figure 1: Change in Drafting Roller Coating Condition*

| Issues | <ul style="list-style-type: none"> <li>Change in drafting roller coating</li> </ul> |
| Reasons | <ul style="list-style-type: none"> <li>Deposition of dust, fiber fly and contamination on the drafting rollers</li> </ul> |

| Interventions | <ul style="list-style-type: none"> <li>Cleaning of top rollers and clearers at every 2 hours interval</li> </ul> |
| Results | <ul style="list-style-type: none"> <li>Reduction in deposition of dust, fiber fly, and contamination</li> </ul> |

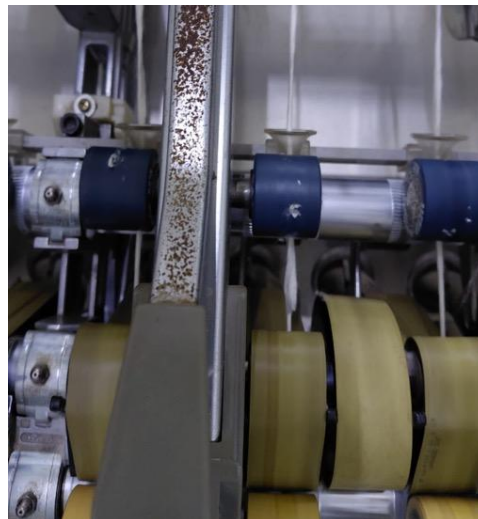
*Figure 2: Sticky Deposition on Back Top Rolls*

| Issues | <ul style="list-style-type: none"> <li>Excessive fly is sticking to the back top rolls of Rieter ring frames</li> <li>End breakage rates of 6.0-7.5 breaks per 100 spindles per hour were recorded, significantly higher than the industry benchmark of below 4.0</li> </ul> |
| Reasons | <ul style="list-style-type: none"> <li>Stickiness in fibers</li> <li>Higher breaker draft of 1.2</li> </ul> |

| Interventions | <ul style="list-style-type: none"> <li>Cleaning of top cots at ring frame with dry cloth based on sticky deposition level</li> <li>Reduce breaker draft to 1.14</li> <li>RH reduced from 51.5% to 48% and temperature increased from 35.5 to 36.6° C</li> </ul> |
| Results | <ul style="list-style-type: none"> <li>Reduction in fly and sticky deposition on ring frame</li> <li>Optimization of end breakage rate</li> </ul> |
