# Spinning Brazilian Cotton

Case Study - 2

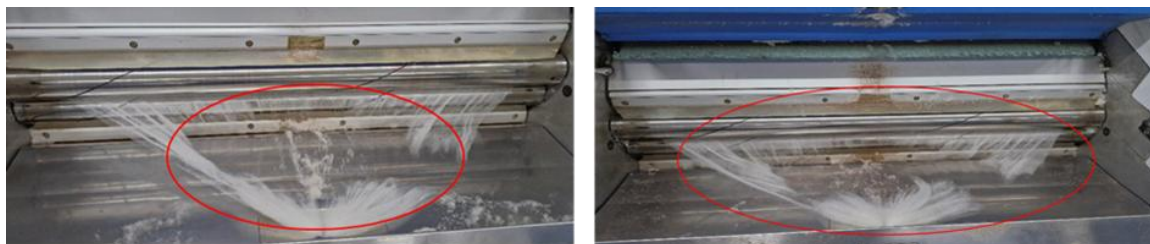
Figure 1: Higher Kitti & Fly Deposition on Web Plate at Carding

| Issues | <ul style="list-style-type: none"> <li>Higher kitti &amp; fly deposition on web plate at carding</li> </ul> |
| Reasons | <ul style="list-style-type: none"> <li>Stickiness in fiber and kitti</li> </ul> |
| Results | <ul style="list-style-type: none"> <li>Lesser kitti deposition in card and fly accumulation on the web plate</li> </ul> |

| Interventions | <ul style="list-style-type: none"> <li>Miracle 869 is sprayed manually on the outer surface of all Brazilian cotton bales at a rate of 1 liter of oil/ton and 1 liter of water/ton to mitigate the stickiness issue. After application, the bales undergo a 16-hour conditioning</li> <li>Beater speed of CLP changed from 650 to 550 rpm</li> </ul> |

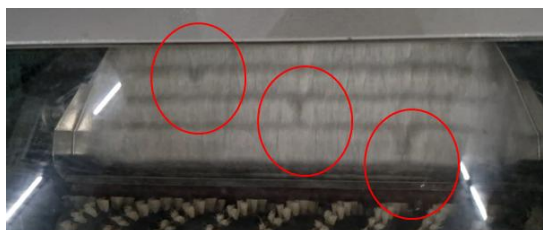
Figure 2: Higher Fleece Cuts

| Issues | <ul style="list-style-type: none"> <li>Higher fleece cuts</li> </ul> |
| Reasons | <ul style="list-style-type: none"> <li>Higher detaching roller pressure</li> <li>Stickiness in fibers</li> </ul> |
| Results | <ul style="list-style-type: none"> <li>Observed fleece cut in 9-10 heads in 16 combers in 100% Brazilian cotton against 5-6 heads in 16 combers in regular mixing</li> </ul> |

| Interventions | <ul style="list-style-type: none"> <li>Detaching roller pressure reduced from 5 bar to 4 bar</li> </ul> |

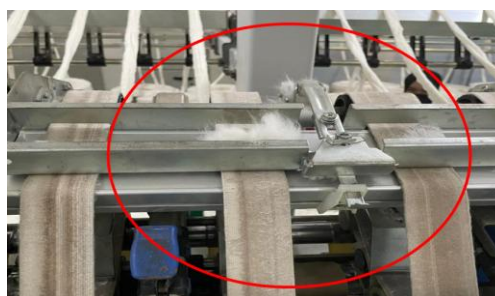
Figure 3: Fly Accumulation on Top Clearer

| Issues | <ul style="list-style-type: none"> <li>Fly accumulation on top clearer at speed frame is higher as compared to regular mixing</li> <li>Higher breakages in speed frame</li> <li>Higher ring frame breakages</li> </ul> |
| Reasons | <ul style="list-style-type: none"> <li>Lower TM in speed frame</li> <li>Stickiness in fibers</li> </ul> |
| Results | <ul style="list-style-type: none"> <li>Reduced fly accumulation, minimization of speed frame breakages</li> <li>Observed 2.5 breaks per 100 spindles per hour at ring frame against 1.37 per 100 spindles per hour in regular mixing</li> </ul> |

| Interventions | <ul style="list-style-type: none"> <li>TM can be increased up to 1.35 off 1.30 upon ensuring that no undrafted issues are observed at ring frame to reduce breakages</li> <li>RH and temperature maintained at &lt;45% and &gt;35°C</li> <li>Clean top cots at ring frame with dry cloth based on sticky deposition level</li> </ul> |
