# Spinning Brazilian Cotton

Case Study - 1

## Process-wise Issues and Interventions

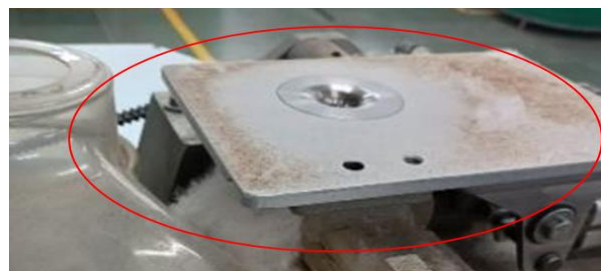
Figure 2: Fiber Choking at Coiler Calendar Roll

| Issues | <ul style="list-style-type: none"> <li>Excessive kitti and fly deposition on carding web plates</li> <li>Fiber choking at the coiler calendar roll with kitti build-up</li> </ul> |
| Reasons | <ul style="list-style-type: none"> <li>Lower waste removal at CLP (pre-cleaner)</li> <li>Higher fiber rupture in CLU (universal cleaner)</li> <li>Lower suction pressure in hoods/licker-in</li> <li>Stickiness in fiber and kitti deposition</li> </ul> |

| Interventions | <ul style="list-style-type: none"> <li>RH reduced to 45% &amp; temperature increased to 35–36°C</li> <li>Grid bar setting in CLP changed from 1.50/2.0 to 2.5/3.0</li> <li>Feed roller to beater setting in CLU changed from 1.5 to 3.5</li> <li>Beater speed of CLU changed from 600 to 515 rpm</li> <li>Suction pressure in card changed from 750 to 850 bars</li> <li>Cleaning frequency increased from one time/shift to four times/shift in carding</li> </ul> |
| Results | <ul style="list-style-type: none"> <li>CLP waste increased from 0.46% to 1.10%</li> </ul> |

| | <ul style="list-style-type: none"> <li>• CLU waste decreased from 1.10% to 0.60%</li> <li>• Card breakages optimized to 12-13/card/day against 5-6/card/day in Indian cotton</li> </ul> |

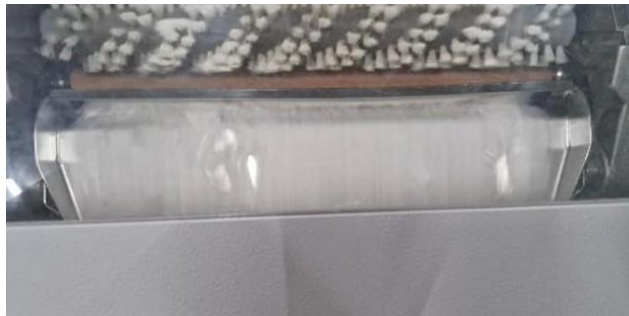
Figure 3: Higher Fleece Cuts

| Issues | <ul style="list-style-type: none"> <li>• Fleece cuts observed at comber</li> <li>• Slightly increased fiber accumulation at the Draw Box in the Omega Lap</li> </ul> |
| Reasons | <ul style="list-style-type: none"> <li>• Lower detaching roller diameter and high pressure</li> <li>• Stickiness in fiber and kitti</li> </ul> |

| Interventions | <ul style="list-style-type: none"> <li>• RH reduced to 45% and temperature increased to 35-36° C</li> <li>• Detaching roller pressure decreased from 5 bar to 4 bar</li> <li>• Detaching roller diameter maintained &lt;24 mm from initial 24.1-24.5 mm</li> <li>• Liquimix coated detaching rollers were used</li> <li>• Noil index changed from 8.0 to 7.7</li> <li>• Strippers were removed from the detaching roller</li> <li>• Cleaning frequency increased from once/shift to four times/shift</li> </ul> |
| Results | <ul style="list-style-type: none"> <li>• Fleece cuts were optimized, final breakages/comber/hour maintained at 3-3.5 against 2-2.3 in Indian Cotton</li> <li>• Noil% in 100% Brazilian Cotton is 14.75%, 13.5% lower as compared to 17.05% in Indian Cotton</li> </ul> |

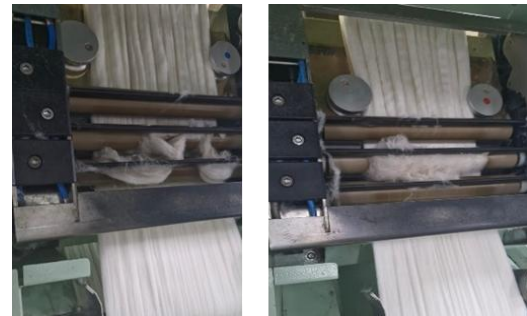
Figure 4: Higher Fly Accumulation in Omega Lap Draw Box
